Max-Liebermann-Villa and Garden in Berlin-Wannsee

General Restoration and Adequation for the Use as a Liebermann-Museum

**European Prize for Cultural Heritage - Europa Nostra Awards 2008
Winner of Medal in Category 1**

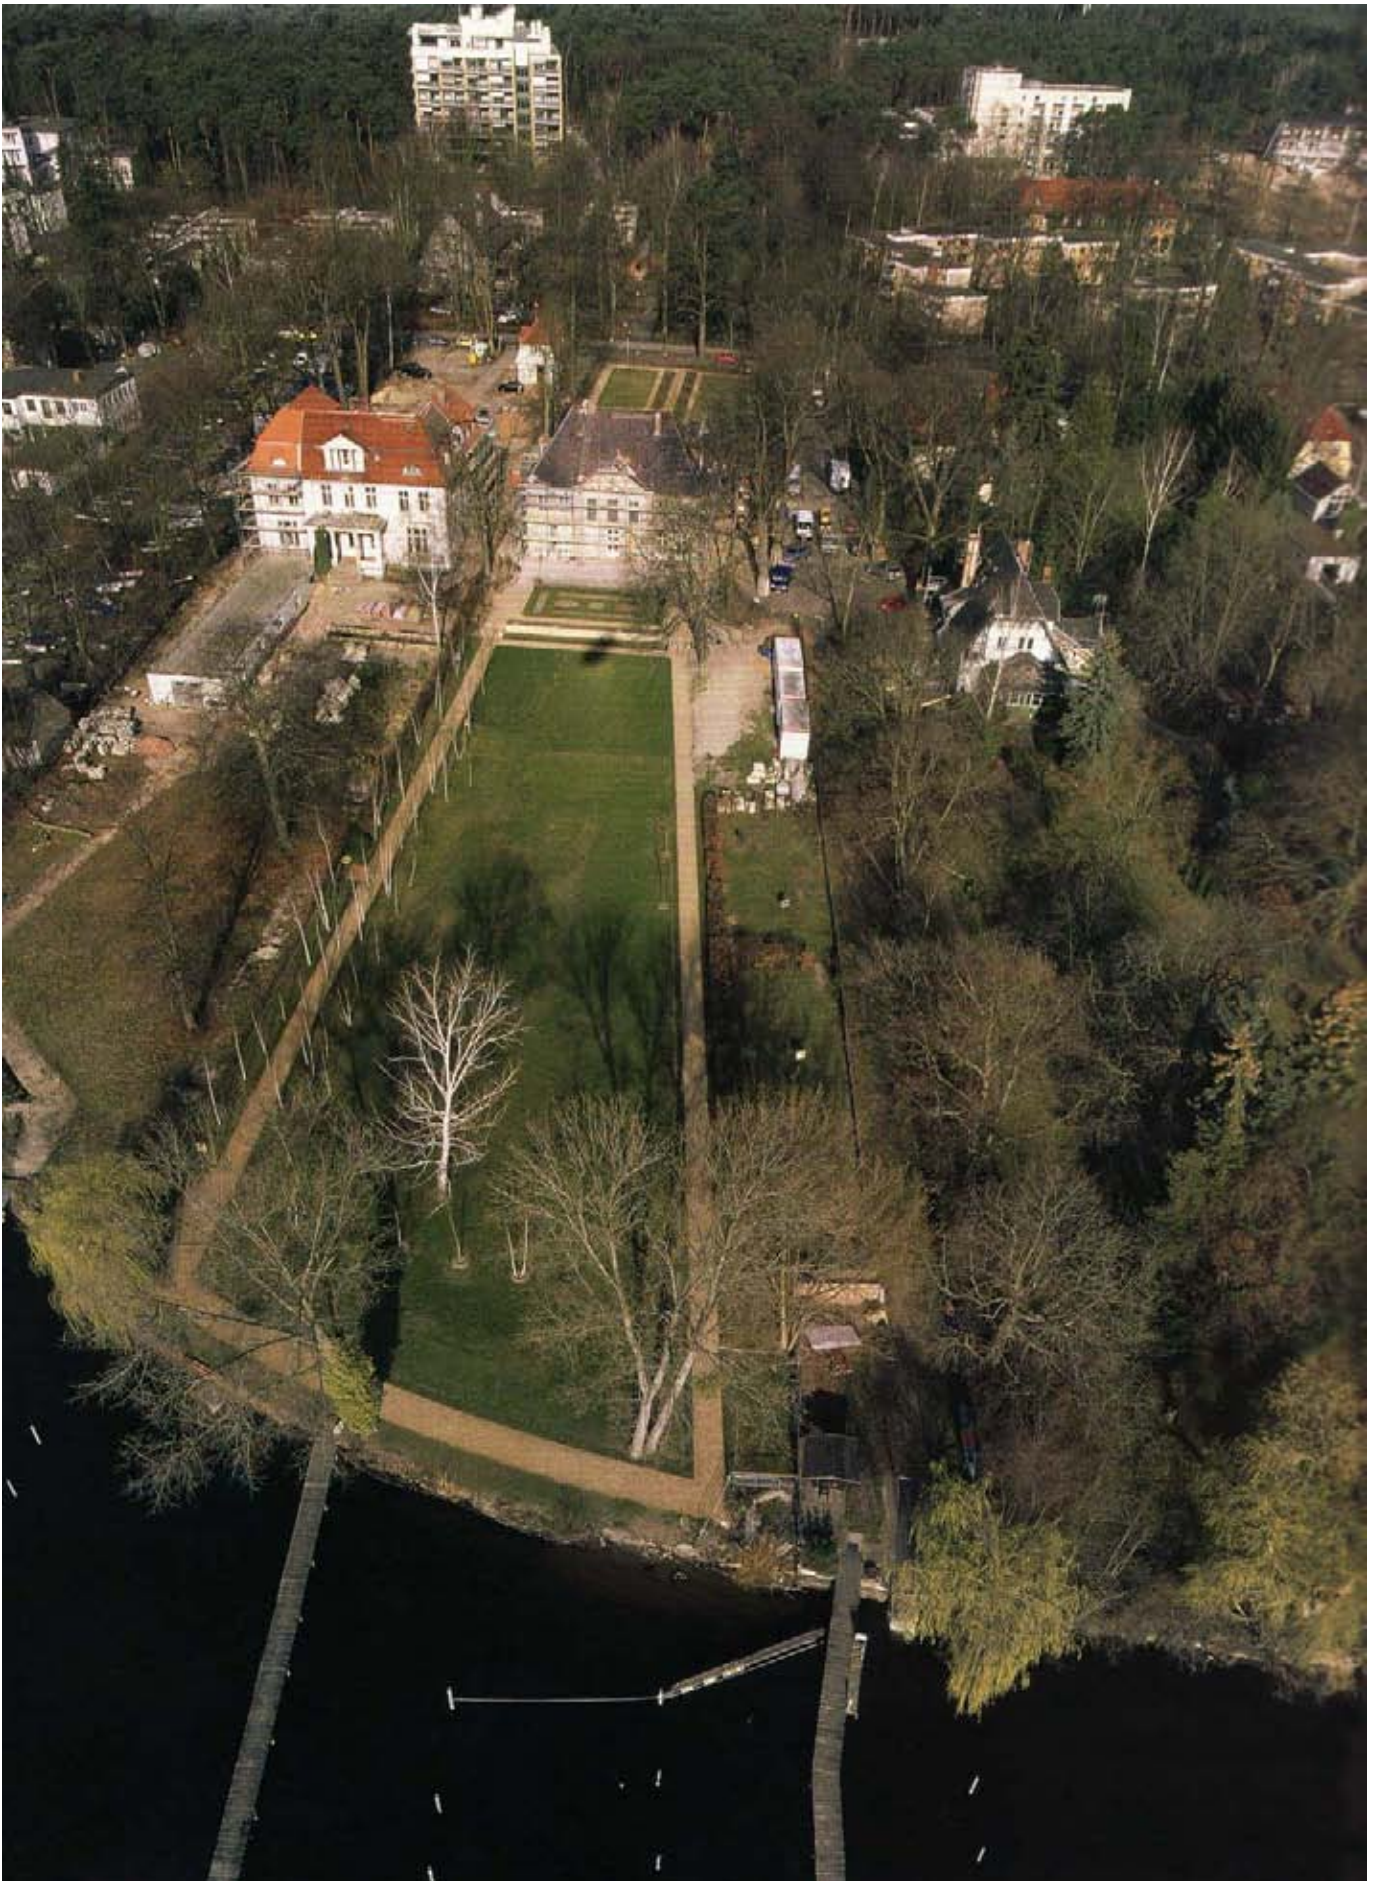
Max Liebermann's Garden in Berlin-Wannsee, on site works, aerial view from the east, April 2005.
Foto: J. Hohmuth, Archives Heritage Authority of Berlin (Landesdenkmalamt Berlin)

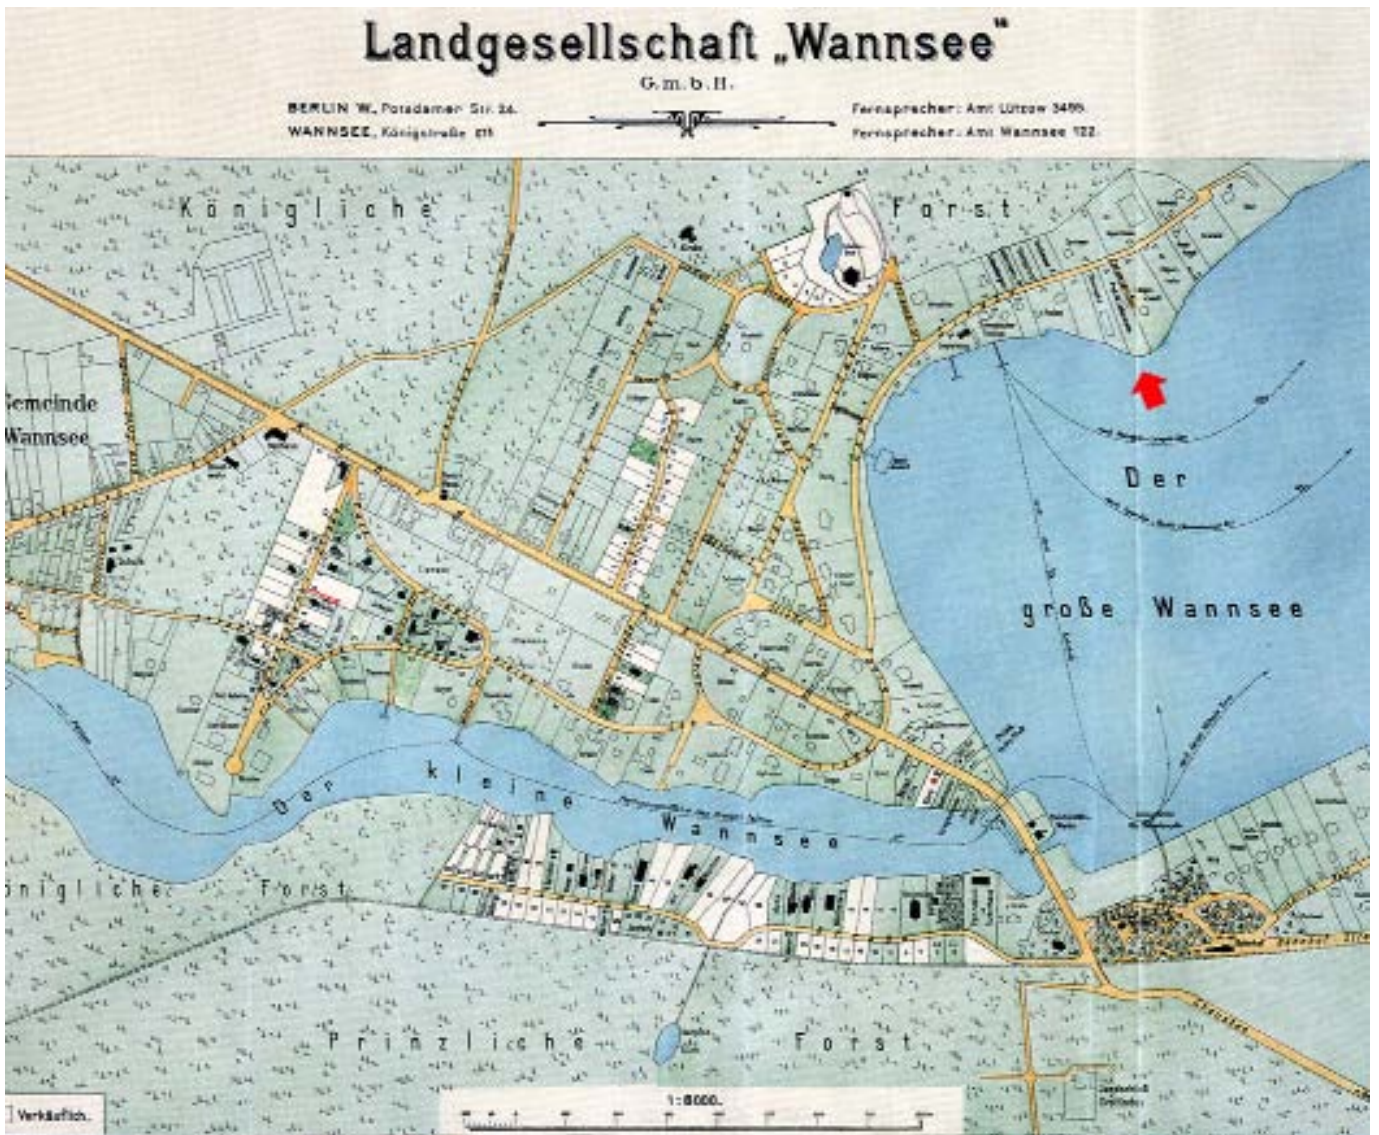
Salesplan of the Wannsee Property Society (Landgesellschaft Wannsee), 1910. Red arrow: Location of Liebermann's Property

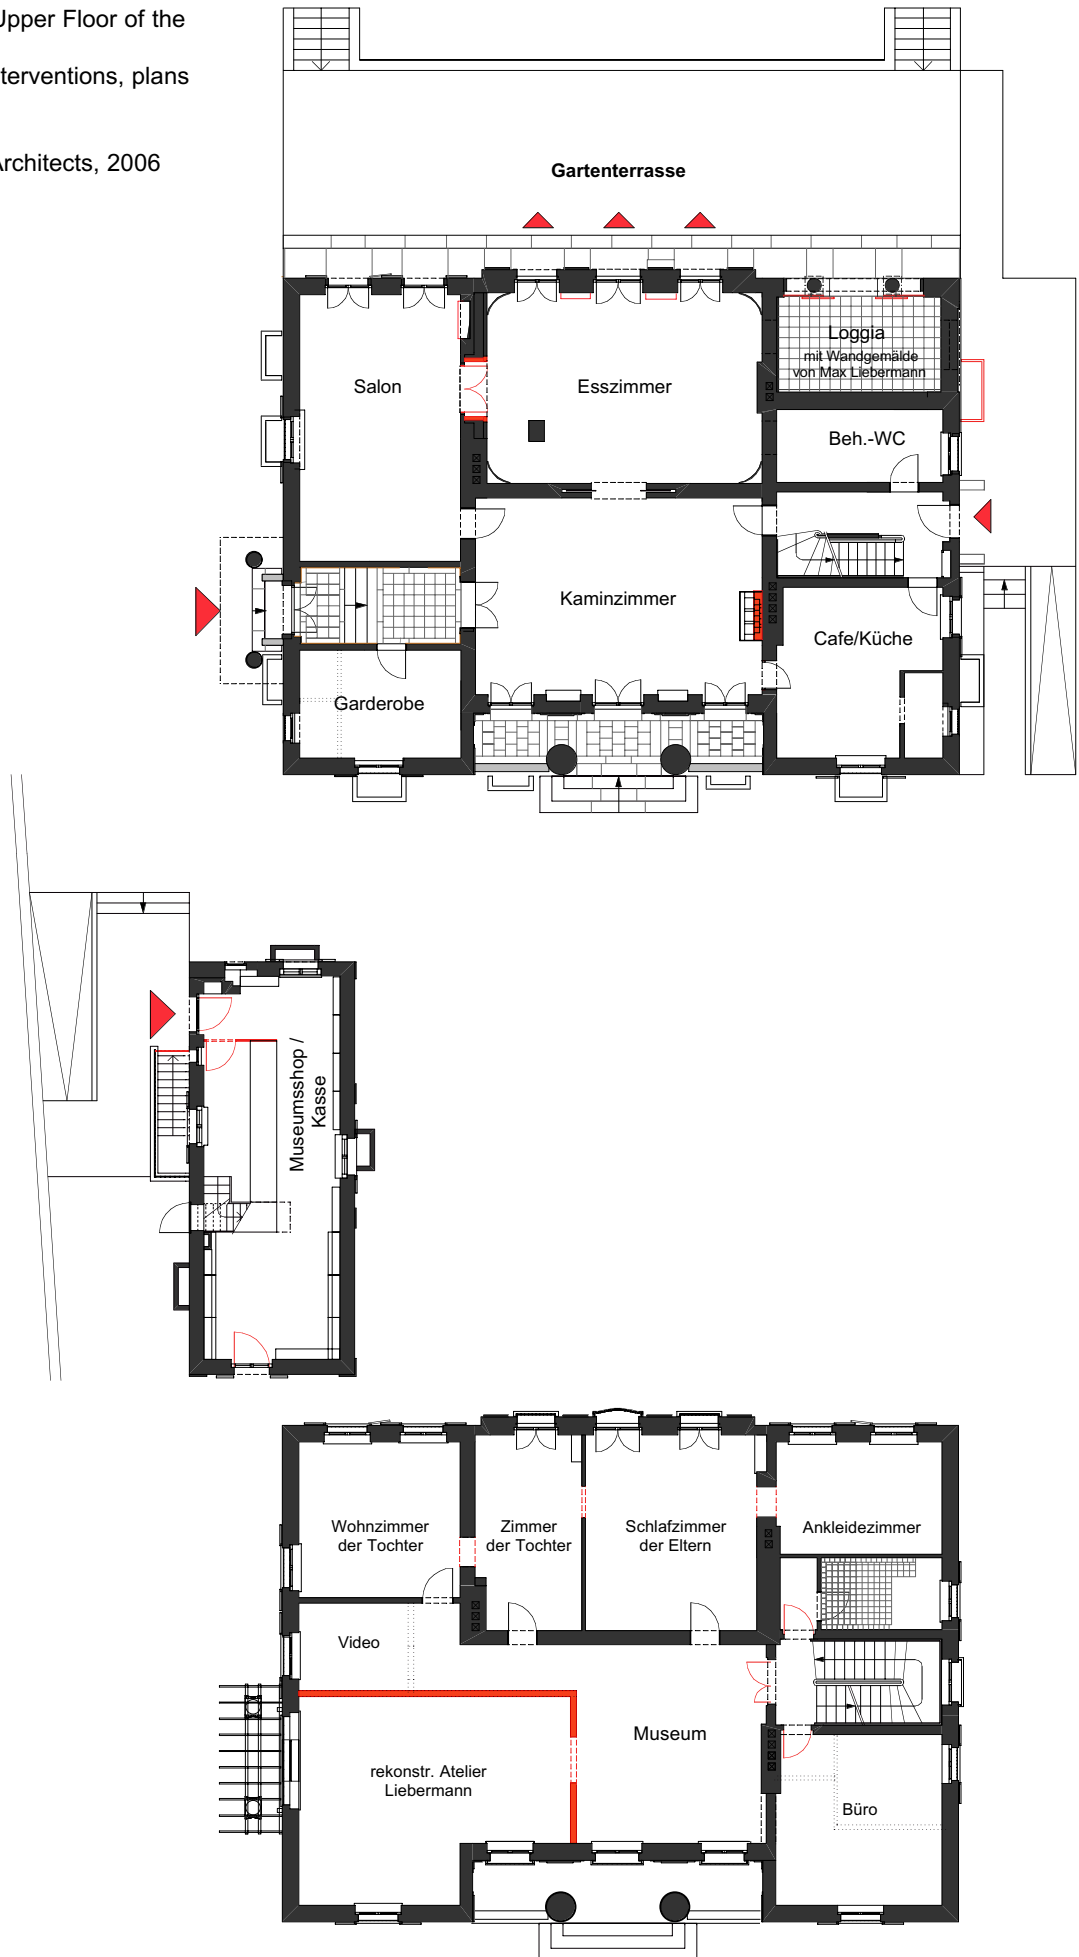
Max-Liebermann-Villa and Garden in Berlin-Wannsee Main Floor Plans with Interventions

Ground Floors and Upper Floor of the main building
Overview on main interventions, plans without scale

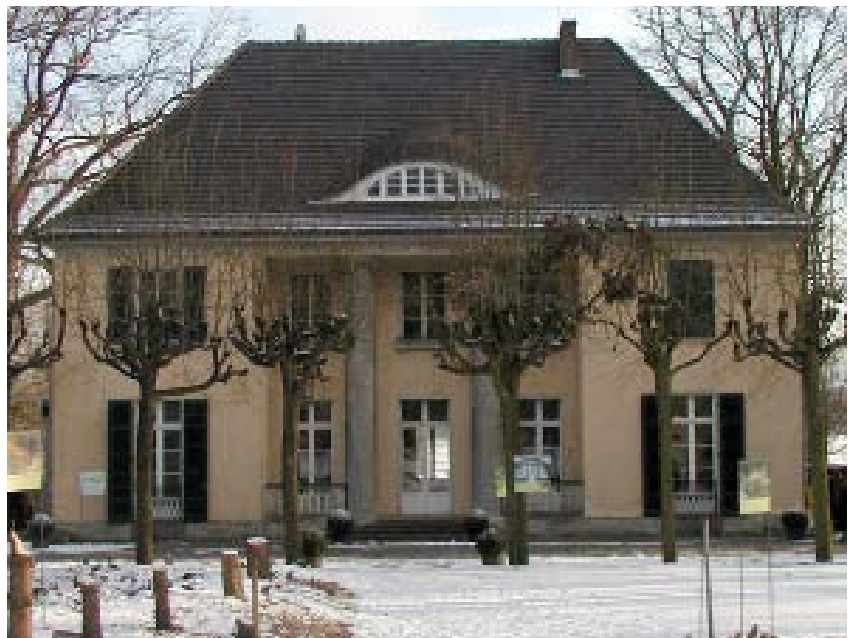
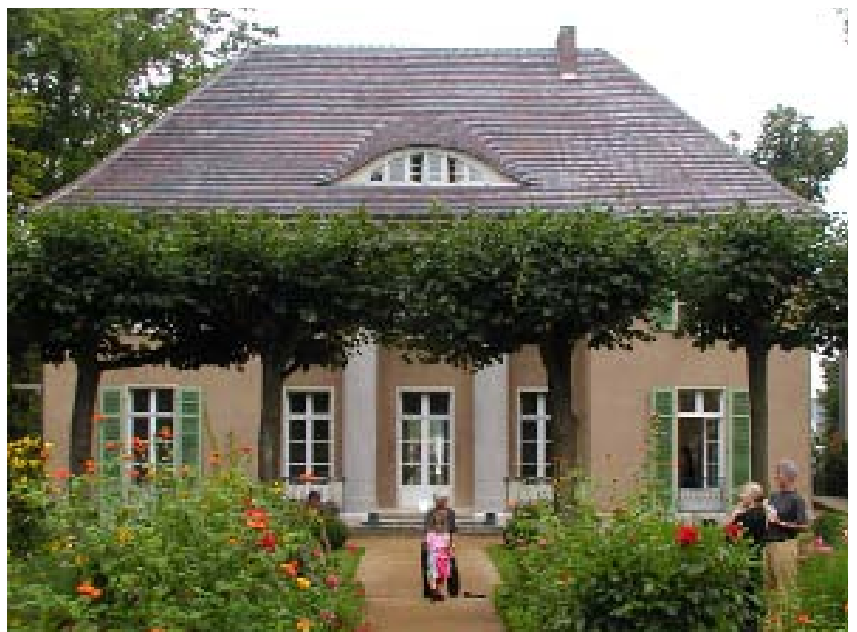
2002, North Façade with coated surfaces

2004, beginning of the works of removal of the coatings from the last decades.

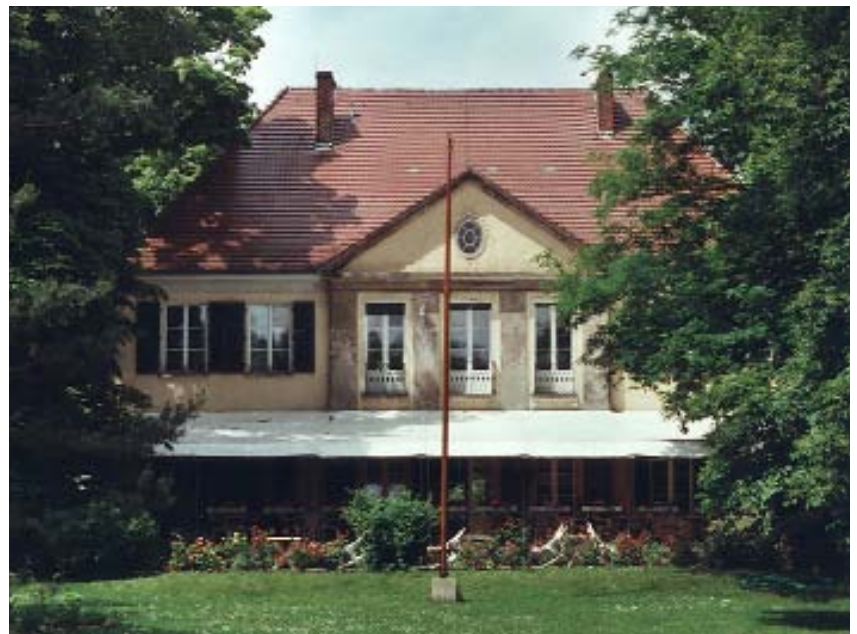
2002, v iew of the East Fassade with the Tent of the Sports Club and the Flag Mast from the early 1940's.

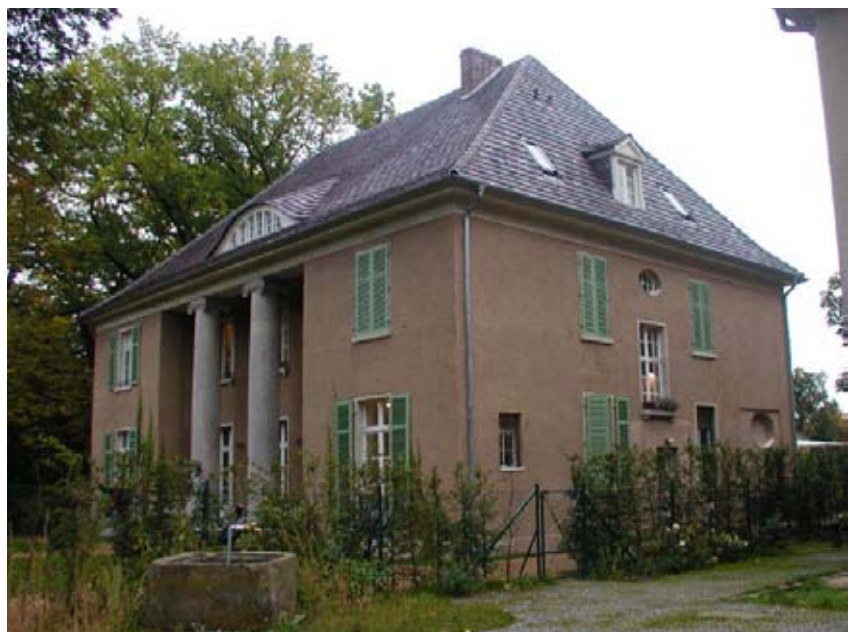
Below:
2003, remains of the connecting corridor were documented before demolition

2006, new ramp of multipurpose access at the South Side.

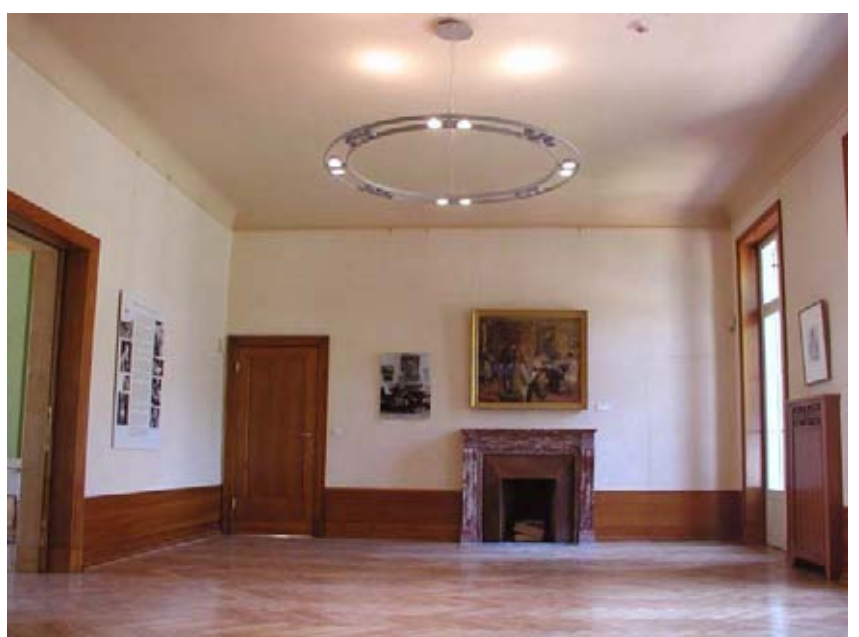
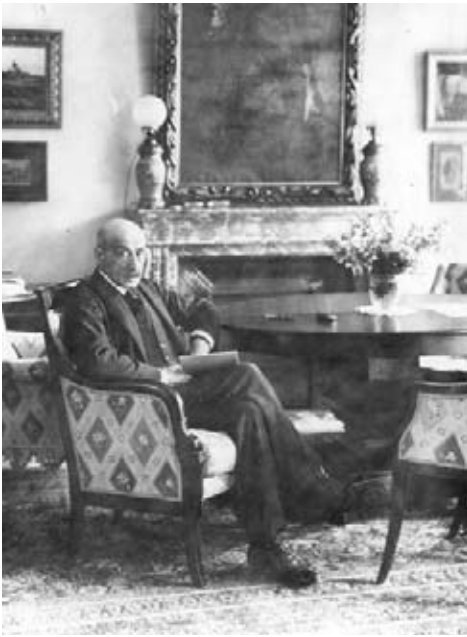
Below:
one of the radiator screens in the mutilated conditions of 2002 and after restoration

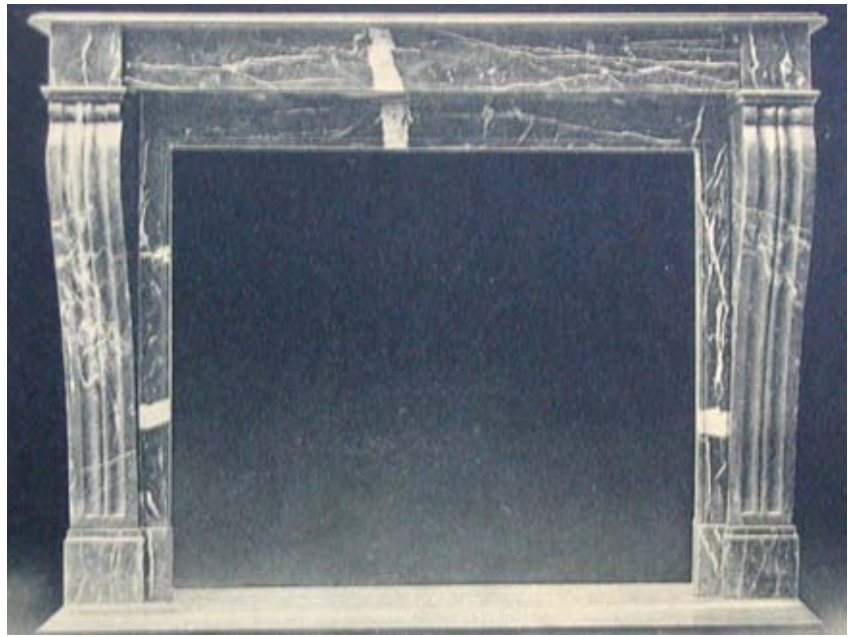
2002, fragments of the fireplace found after the dismantling of the bar counter.

2006, view of the reconstructed fireplace with a contemporary screen design.

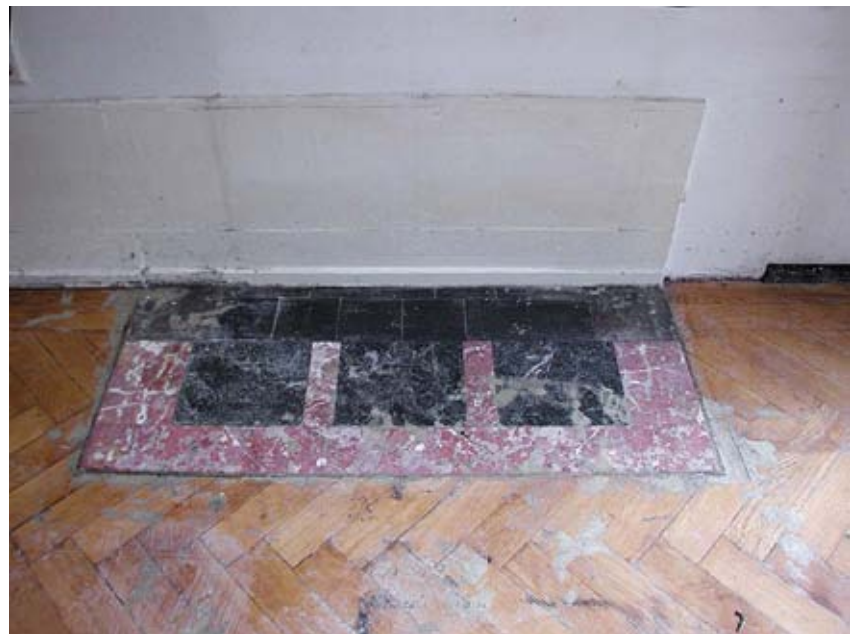
2006, the door opening at the southern wall by the Sports Club was kept as a direct access of the public to the kitchen and it was redesigned as a jib door to permit the recovering of the general wall proportions.

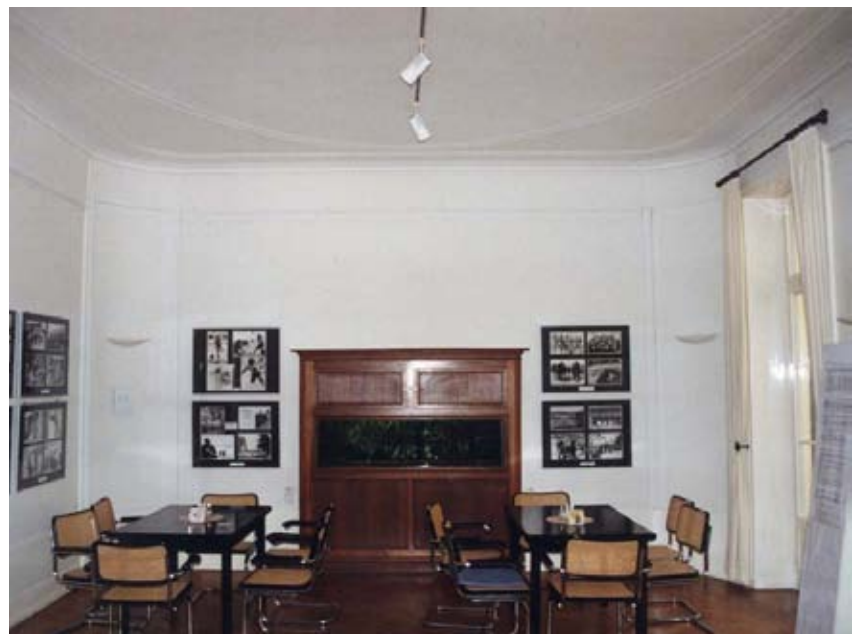
2002, view of the Dining Room's north wall with a built-in aquarium replacing the former double doors.

2006, view of the Dining Room's north wall with the restored surfaces and the reconstruction of the double doors.

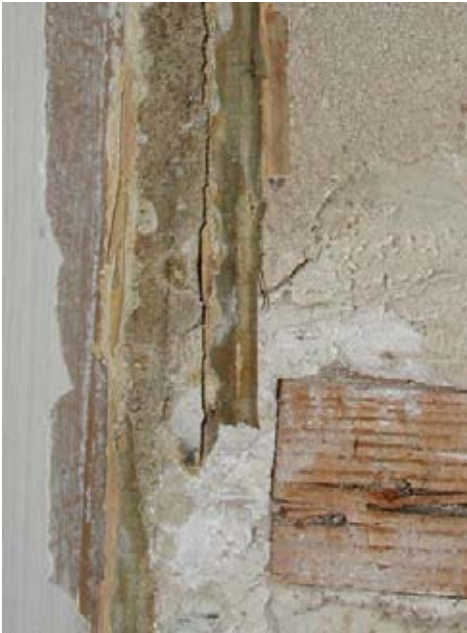
2005: Fragment of the original printed wall paper from 1911

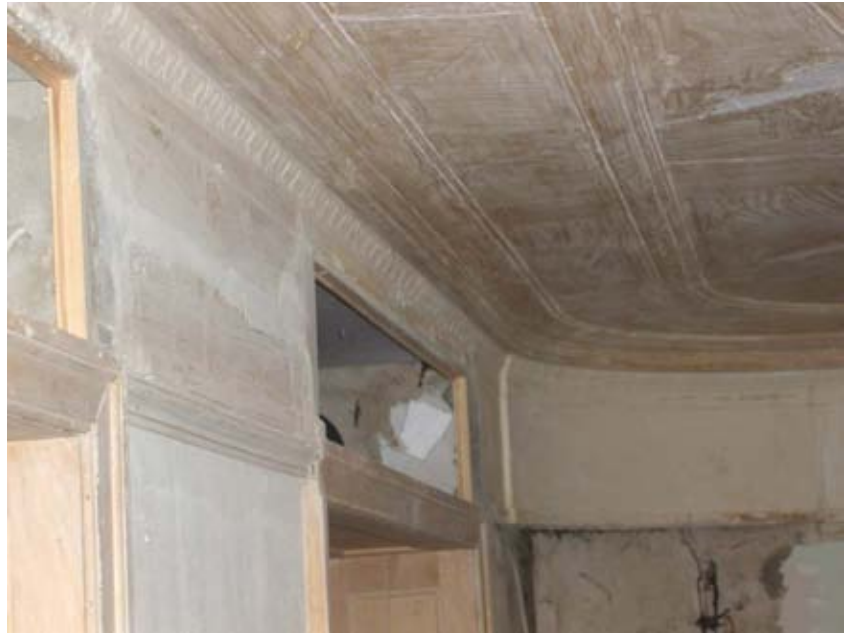
2006, the cleared Stucco before it's treatment with shellack coating.

2006: the Master Painter applying the third from six paint coatings over the paper covered walls.

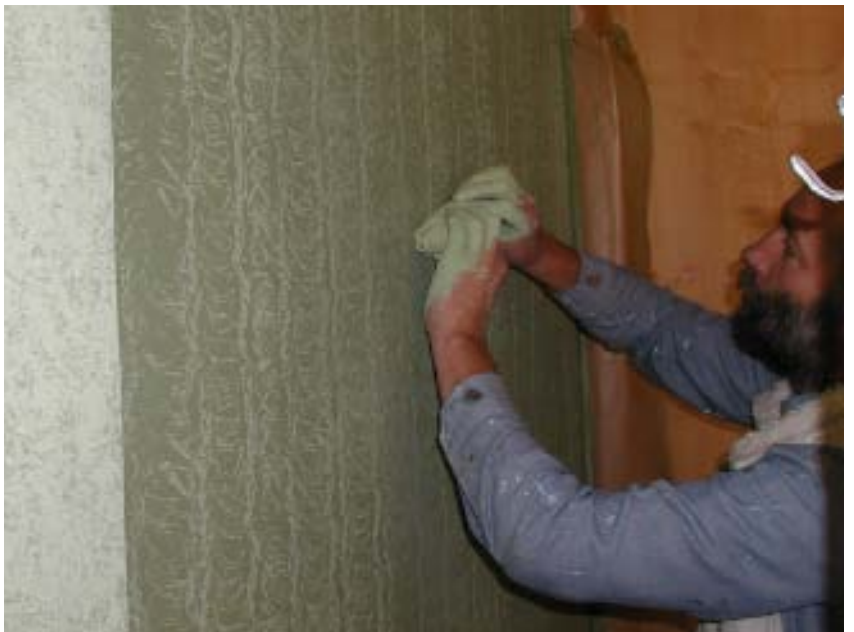
2006, detail of the reconstructed door between Living Room and Dining Room.

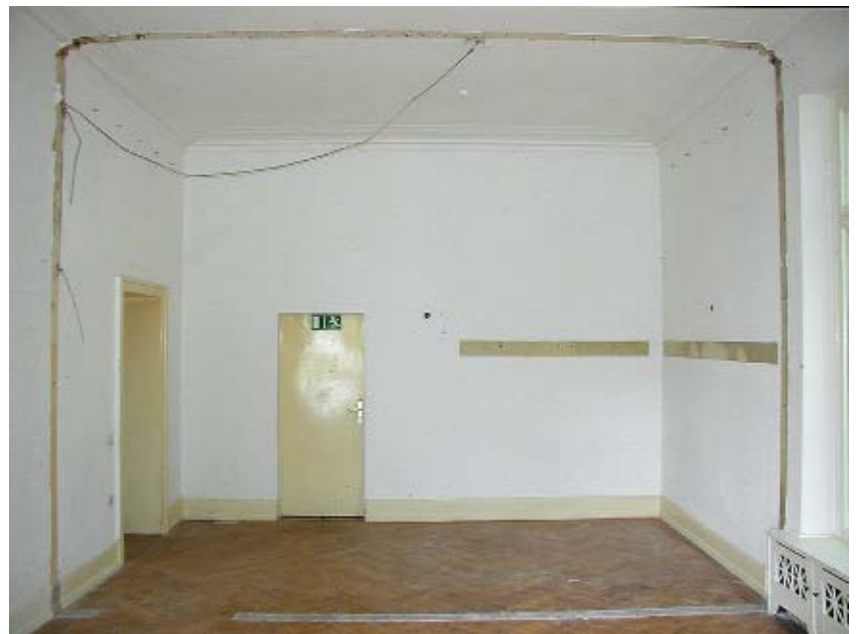
2002, western wall of the Living Room
after the demolition of an added wall from
1971.

2006, partial views of the restored Living
Room showing one original (right) and one
reconstructed (left) wooden masks of radi-
ators as well as the reconstructed door to
the Dining Room.

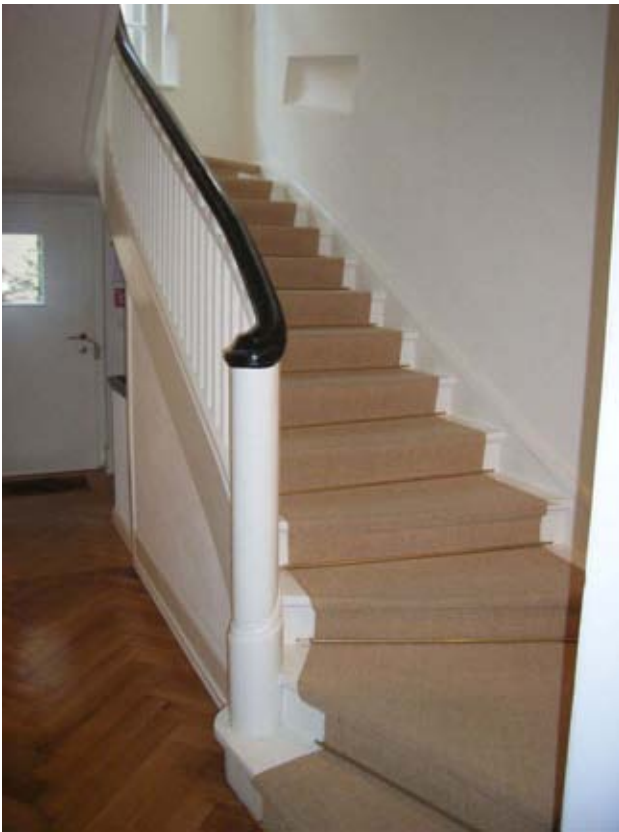
2006, the staircase viewed from the ground floor.

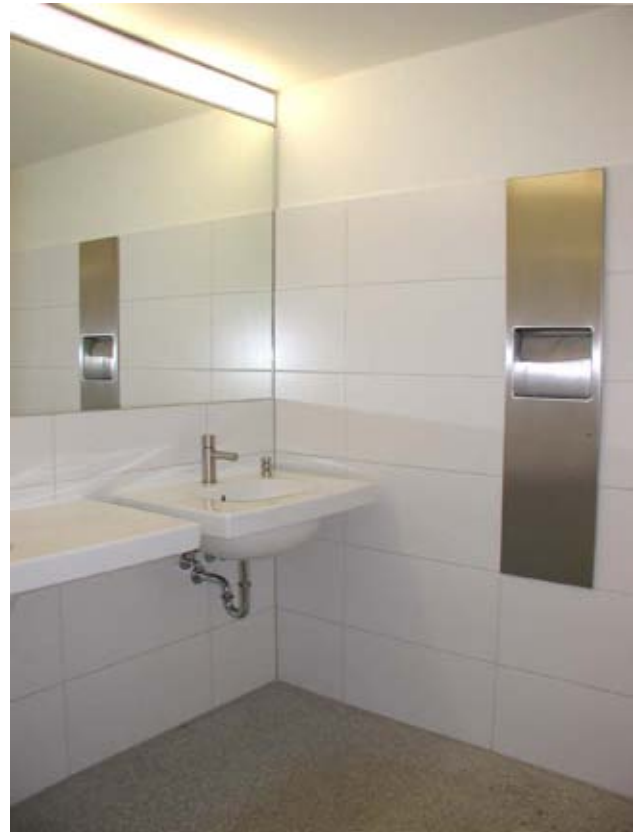
2006, washroom of the visitors' toilet area, placed in the cellar of the main House.

2006, contemporary design for the Cafe service counter in the former kitchen.

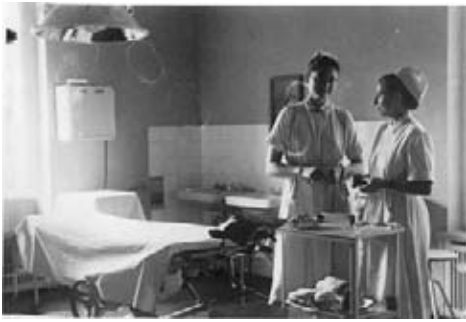
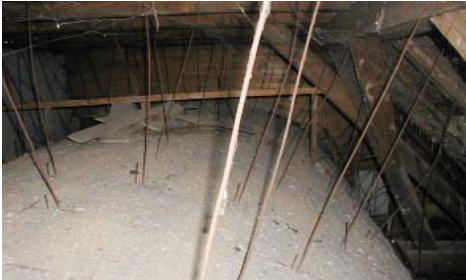
Above:
1954, view of the northwestern corner of the former Studio, used as a surgery room of the hospital.
2003, rear side of the Studio's ceiling vault.

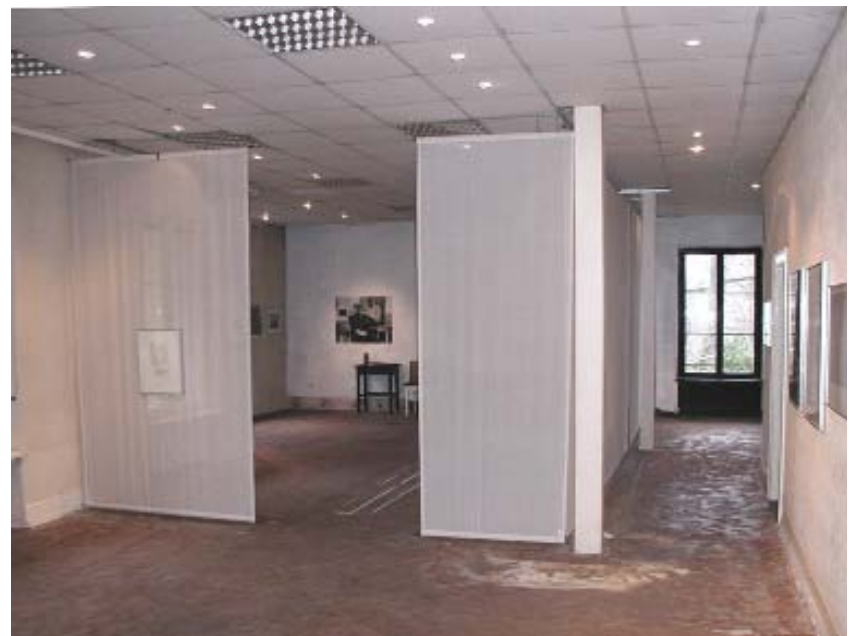
September 2002, for the opening of the unrenovated House to the general public the walls of the former Studio were simulated with the available means of the Liebermann Society at that point .

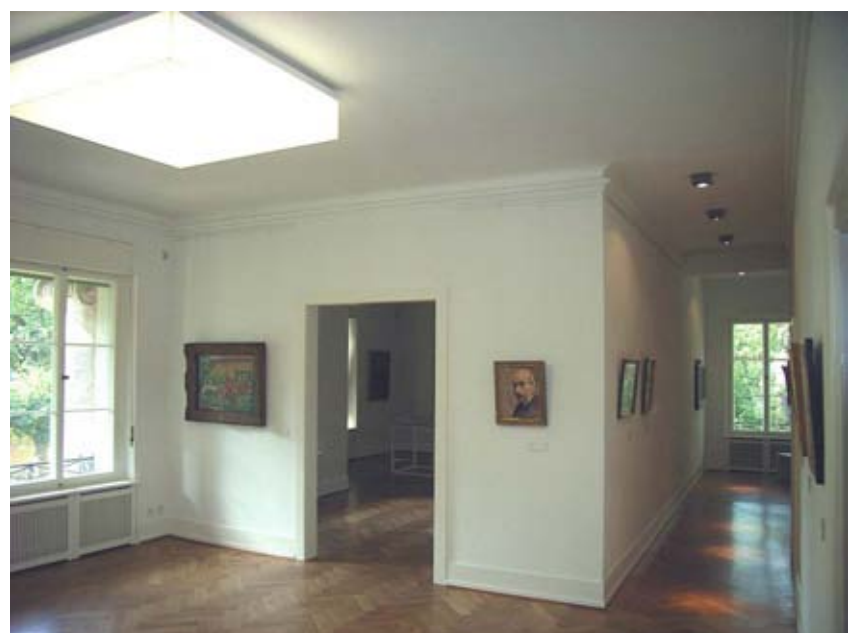
2006, the floor plan of the upper floor and the Studio's geometry was reconstituted.

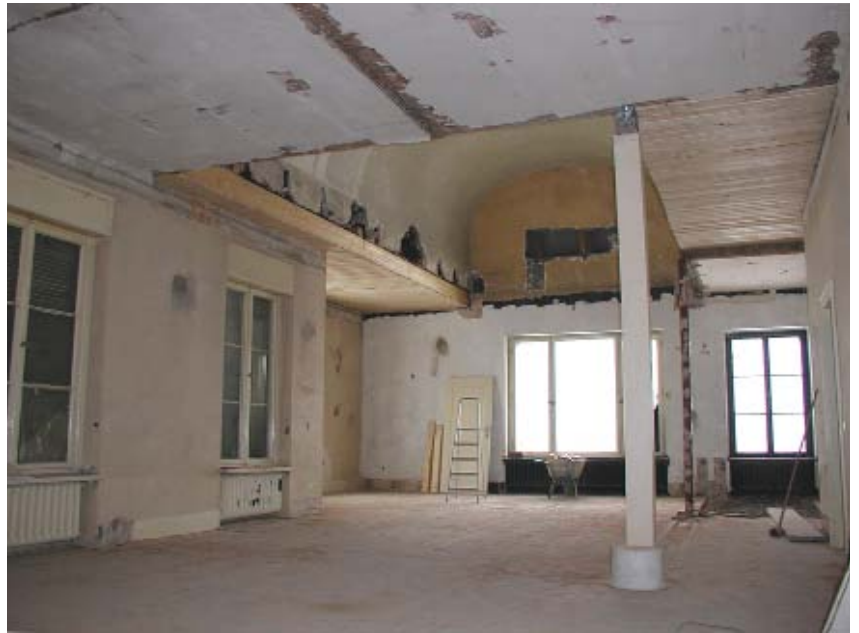
2006, Liebermanns former Studio, view to
the North and to the Southeast.
The Studio is now devoted to showing his
larger format paintings.

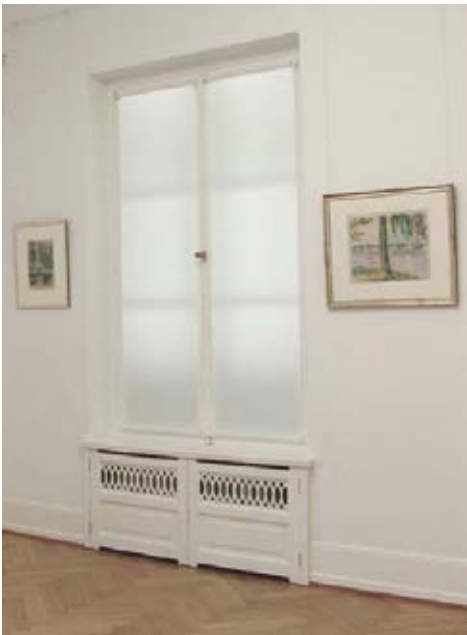
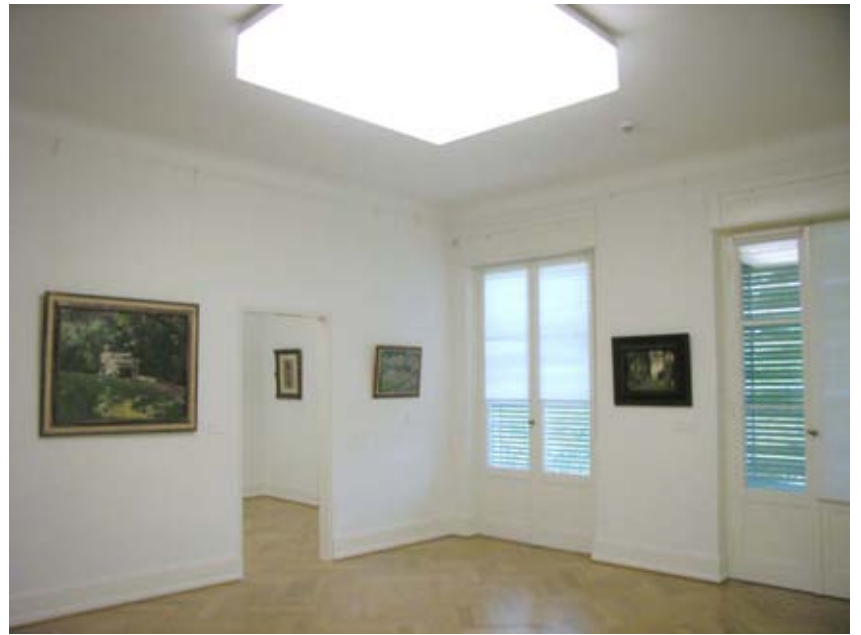
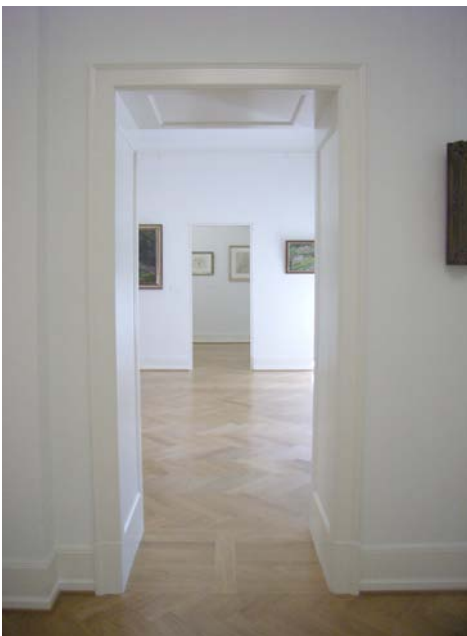
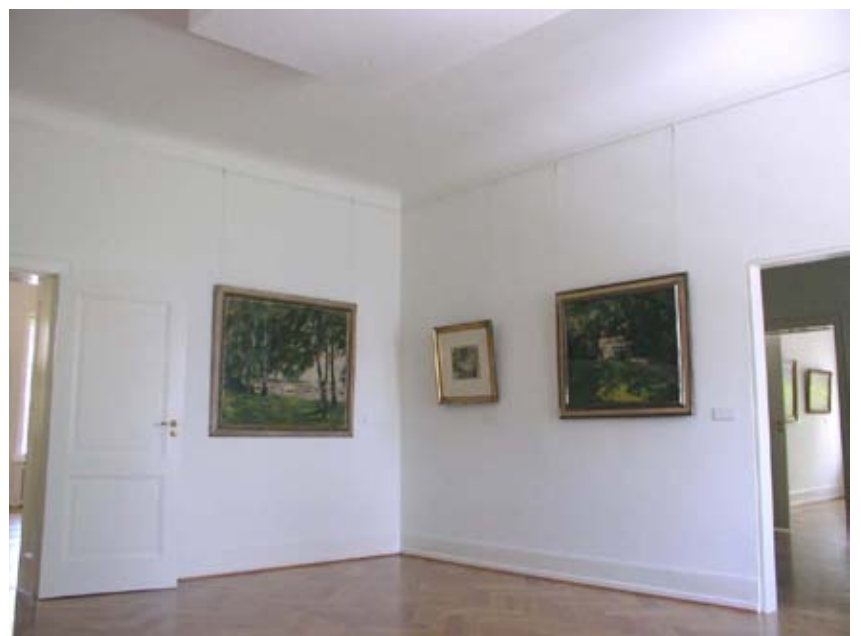
2006, several Museum spaces on the Upper Floor.

Above: Detail of the Living Room of the daughter and room sequence from the closet of the parents towards North.

Right: the Parents' Bedroom, views to the Northeast and Northwest.

Below: Detail of the reconstructed door frame and of the lamp designed for the Museum spaces.

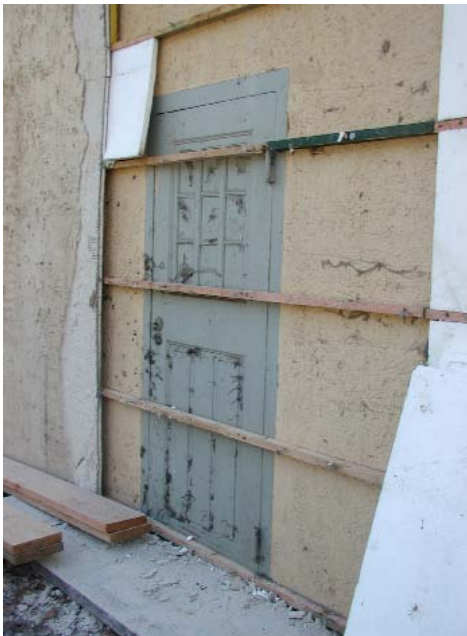
2002 and 2006, view from the North

2004, the dismantling of the insulation layers exposed the hidden door to the internal stairs.

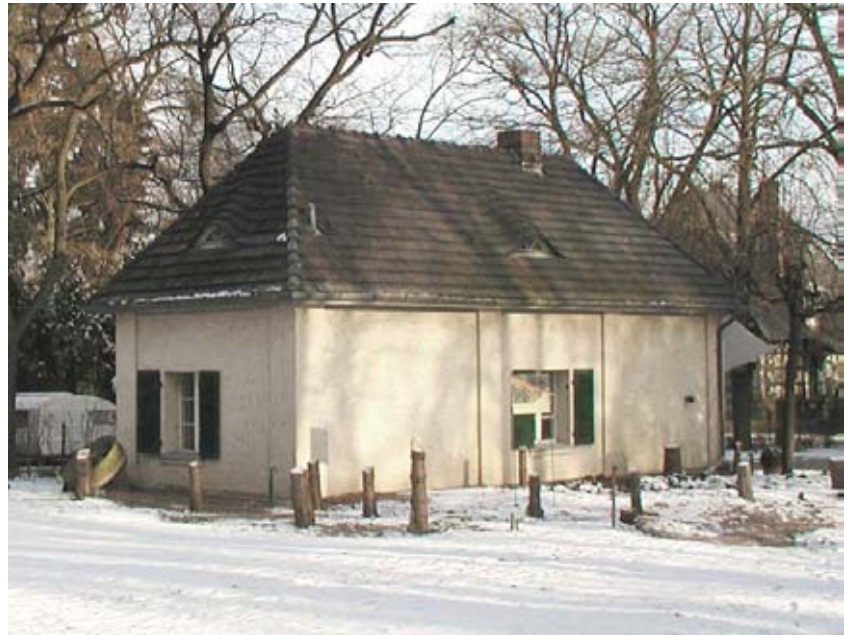
2003, view from Southwest

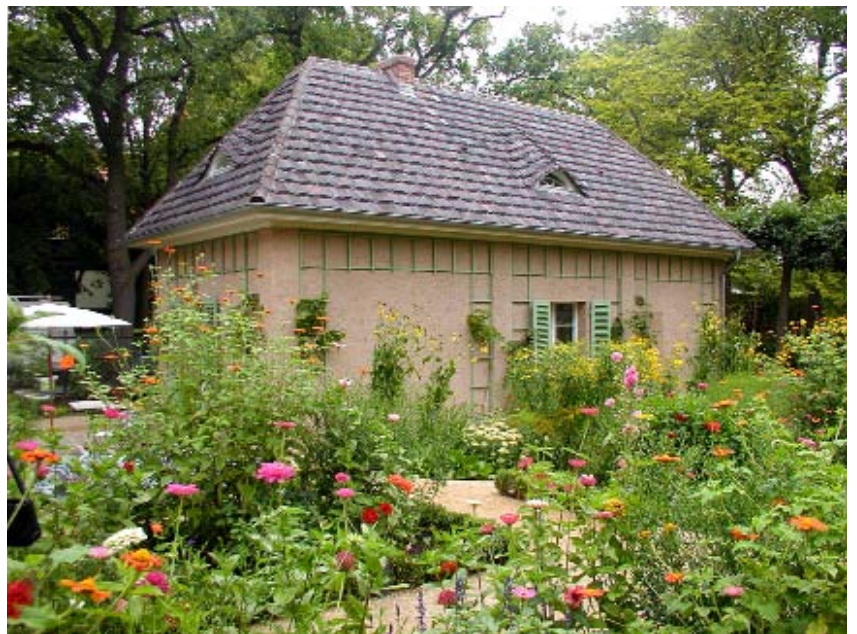
2006, view from Southwest and Details

On the West Façade, the former window was transformed into a door to allow the public flow into the garden. The original shutters were extended and marked as such, the new door respects the order of the other façade openings and shows the clear addition made.

On the South Façade, a 1 sqm large surface documents the colour and texture of original plaster which had to be redone.

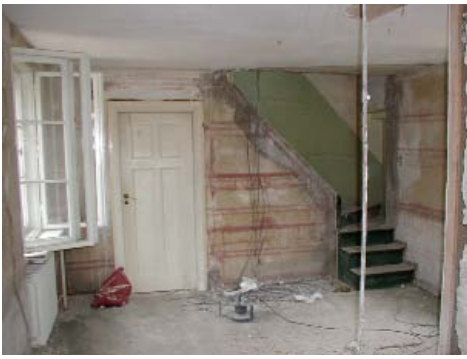
2003, general condition of the internal spaces of the Gardener's House after the demantelling of recent interventions.

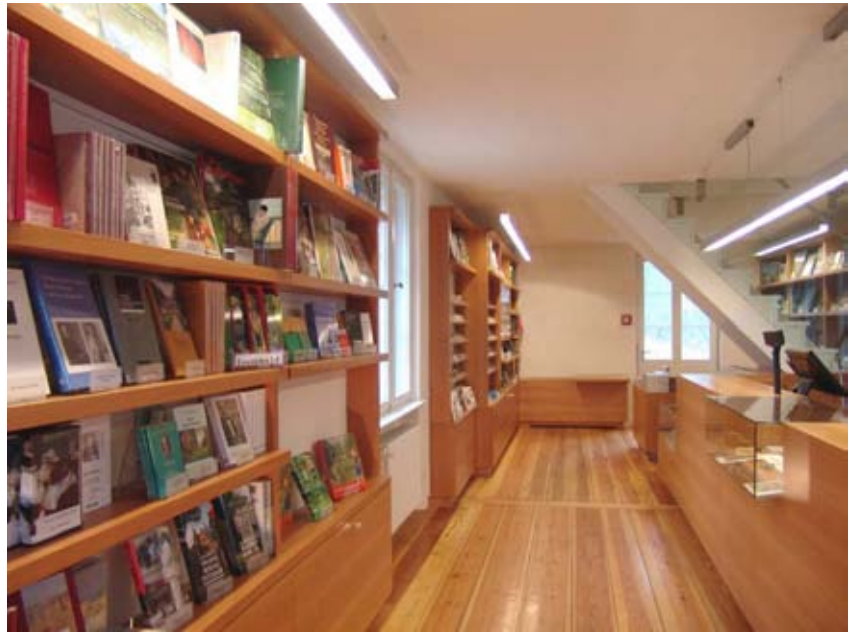
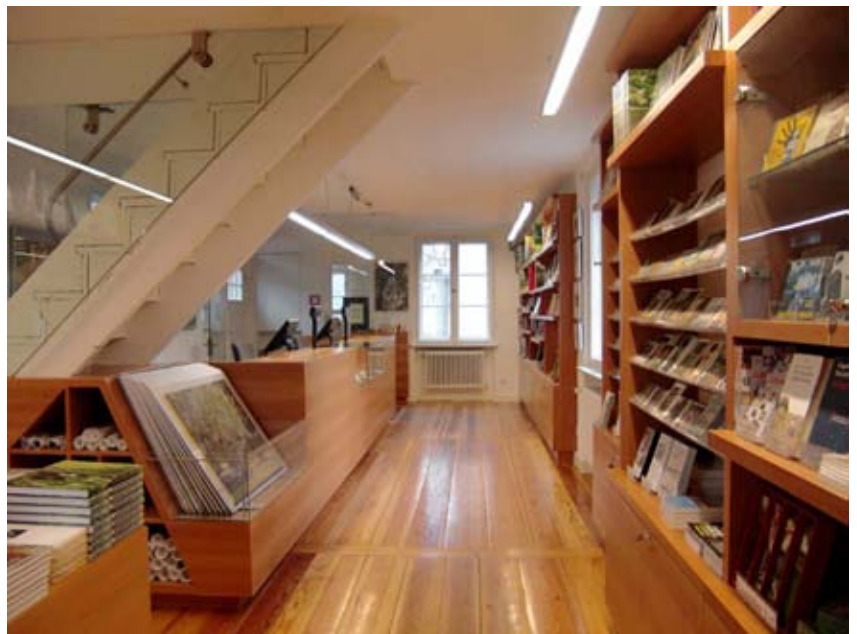
2006, the demolition of the internal walls permitted to create a linear space that serves both as tickets office, information center and Museum Shop.

The original wooden stairs remained as a solitary in the middle of the room, the diversion of the lowest steps was accentuated by the use of the same wood as all contemporary shop furniture.

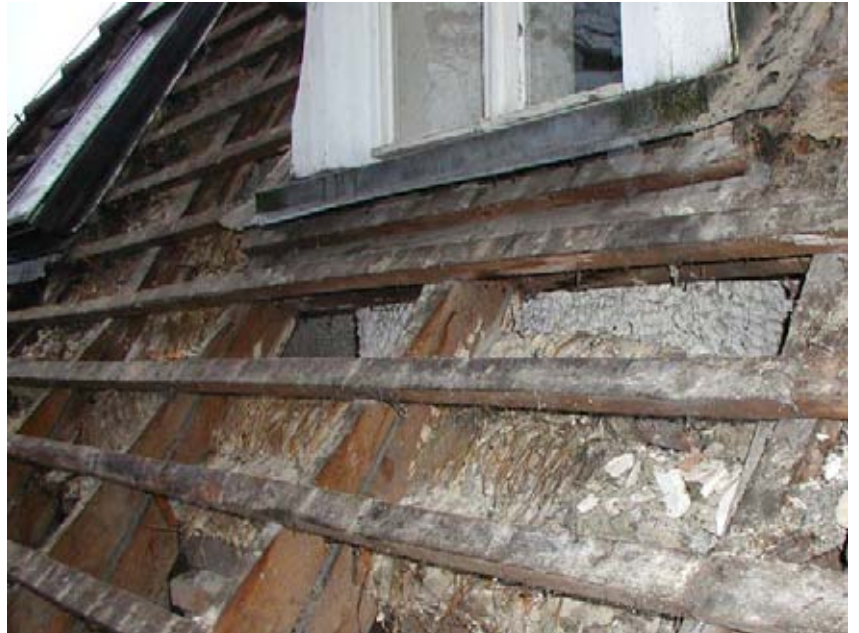
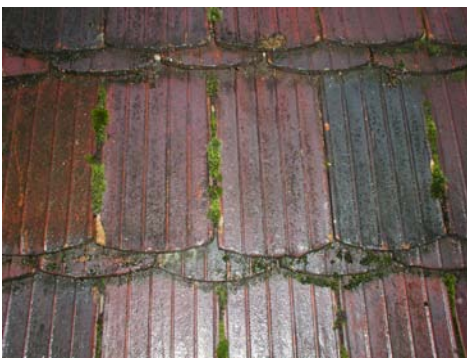
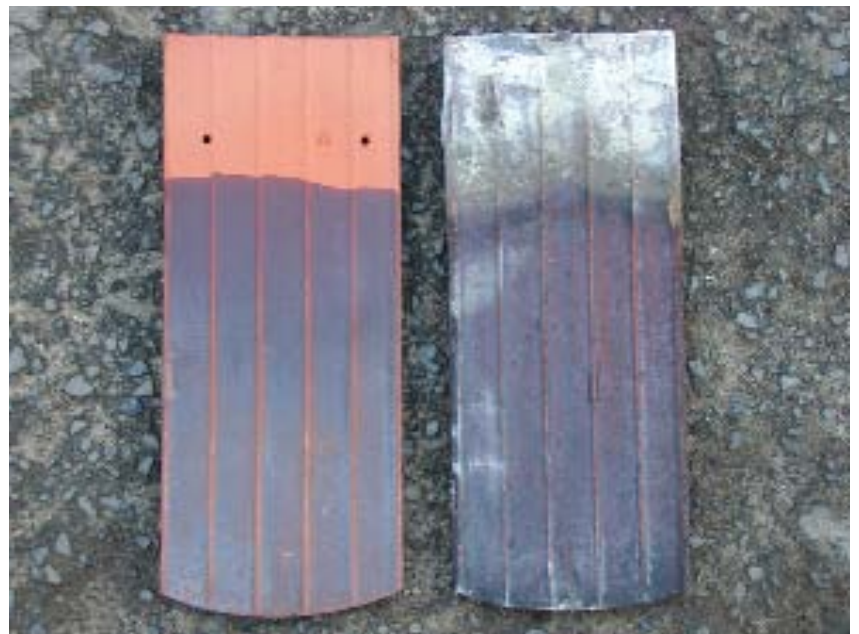
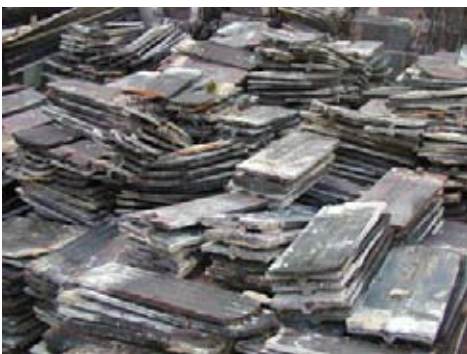
The relocation and recycling of original materials was a central aspect for regaining the original appearance of roof surfaces. In case of the façades, any unnecessary loss of original plaster was carefully avoided.
