Max-Liebermann-Villa and Garden in Berlin-Wannsee

General Restoration and Adequation for the Use as a Liebermann-Museum

**European Prize for Cultural Heritage - Europa Nostra Awards 2008
Winner of Medal in Category 1**

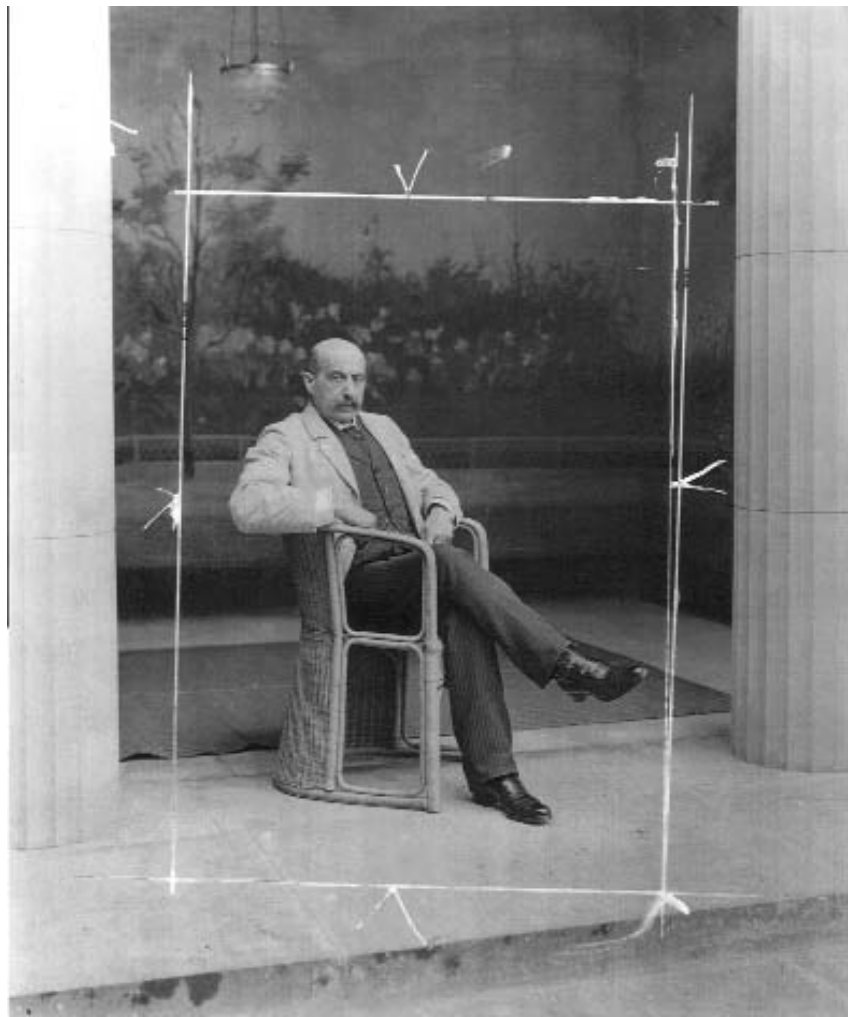
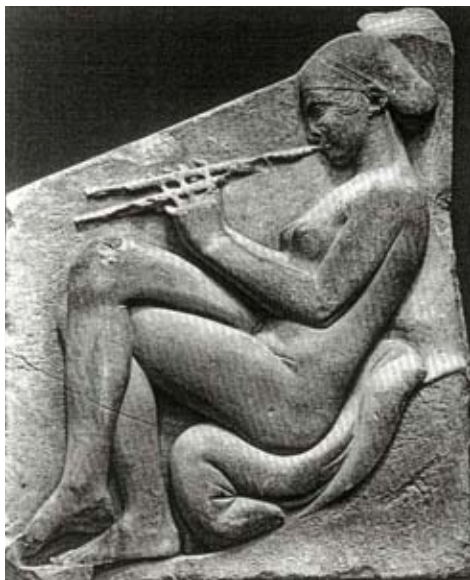
Detail of one of the motifs of the Ludovisi-Throne (470-450 B.C.), used by Liebermann for the upper fries on the side walls in Wannsee.

The frescoes of the subterranean Garden Room of the Villa di Livia in Prima Porta in Rome (around 10 B.C.).

The room before 1954 as the murals were transferred to the Museo Nazionale Romano, the way Liebermann saw it on site.

Detail of the wall that served as inspiration for the main wall in Wannsee

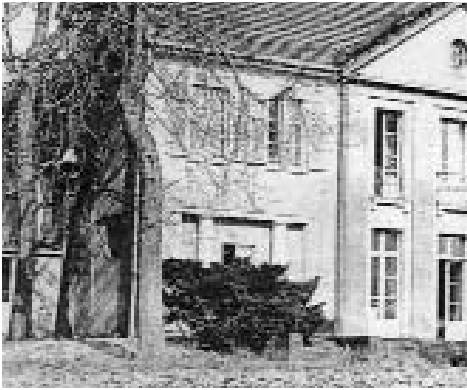
1968, the Loggia opening closed with brick work after the years of hospital use.
2003, ongoing prospection works.

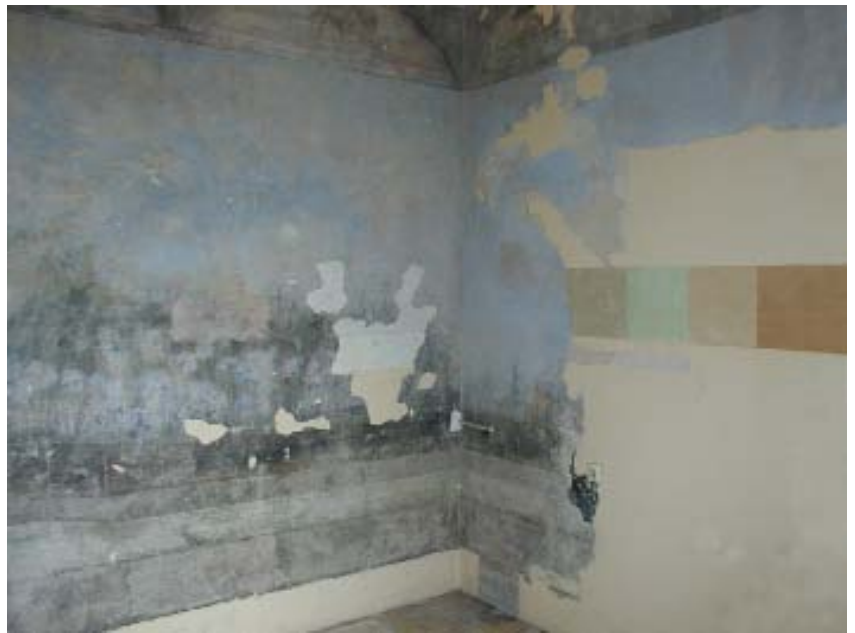
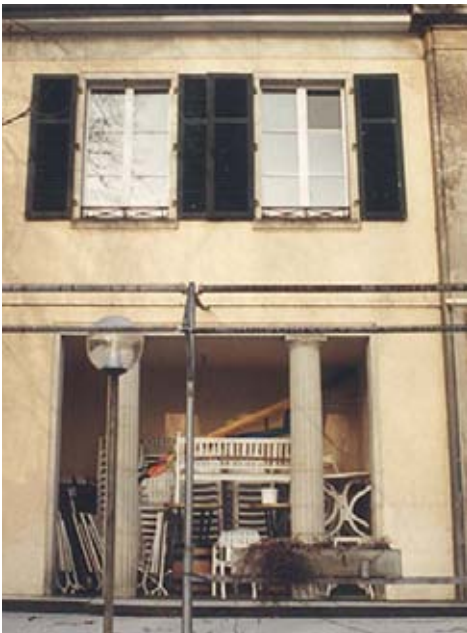
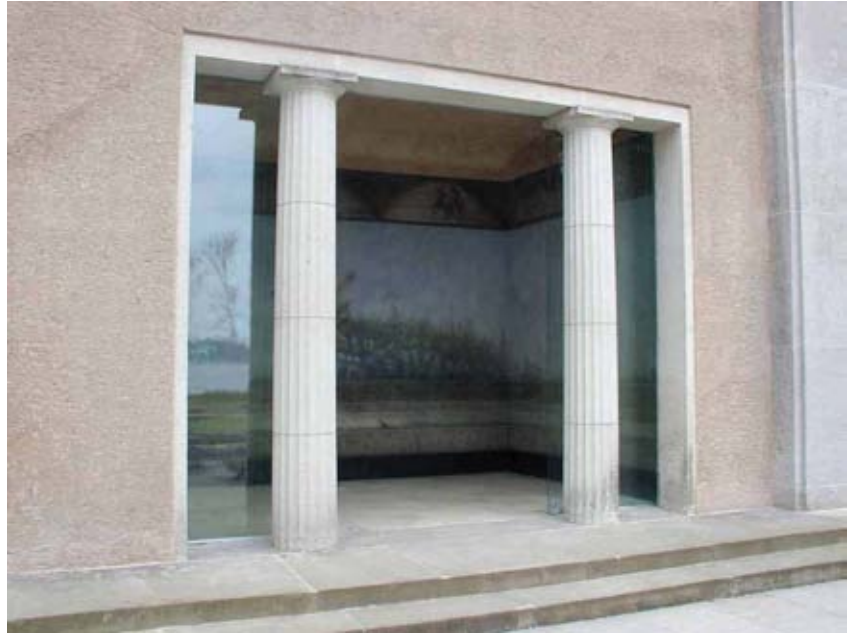
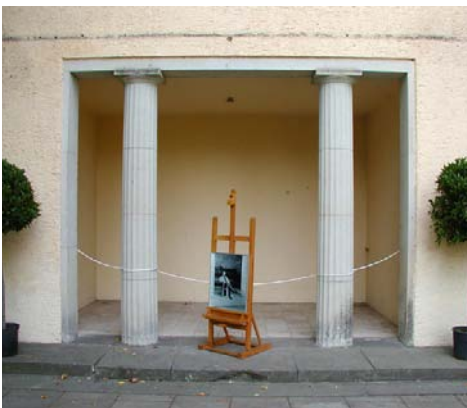
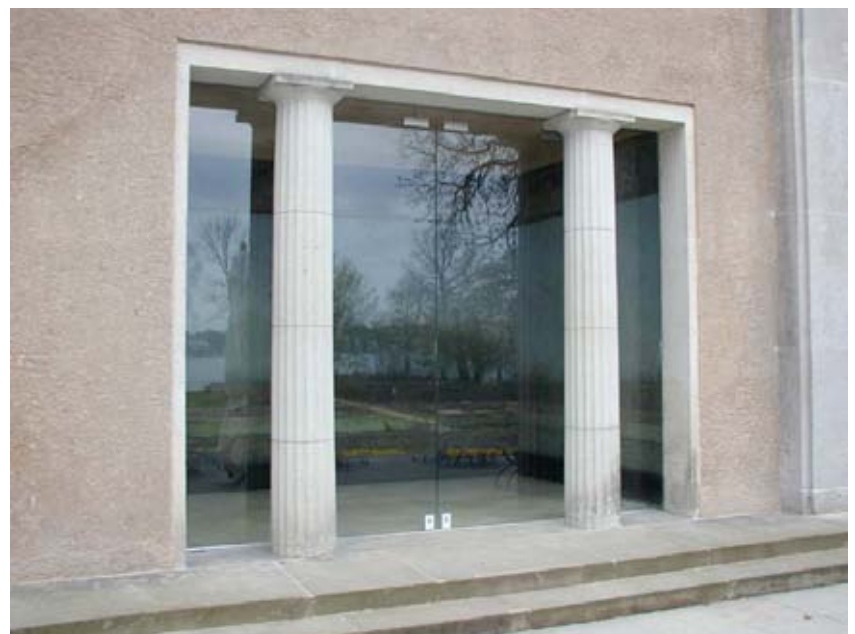
Below:
2002, conditions under the Sports Club and
after September under the Max
Liebermann Society

1006, the frameless glasing enables the
visitors the experience the mural painting
in connection to the Garden and protects
the Art Work after hours.

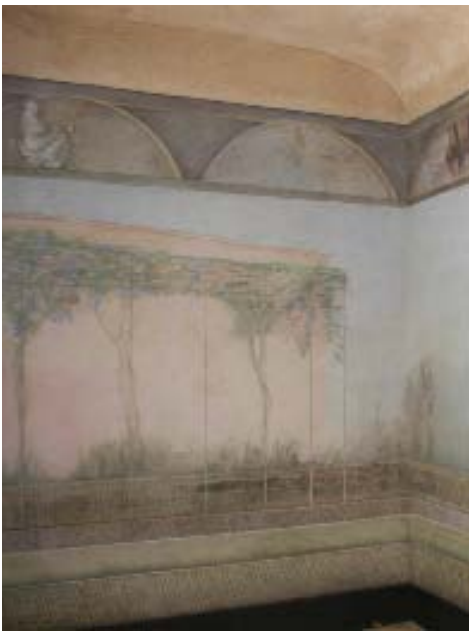
Left wall with pergola motif

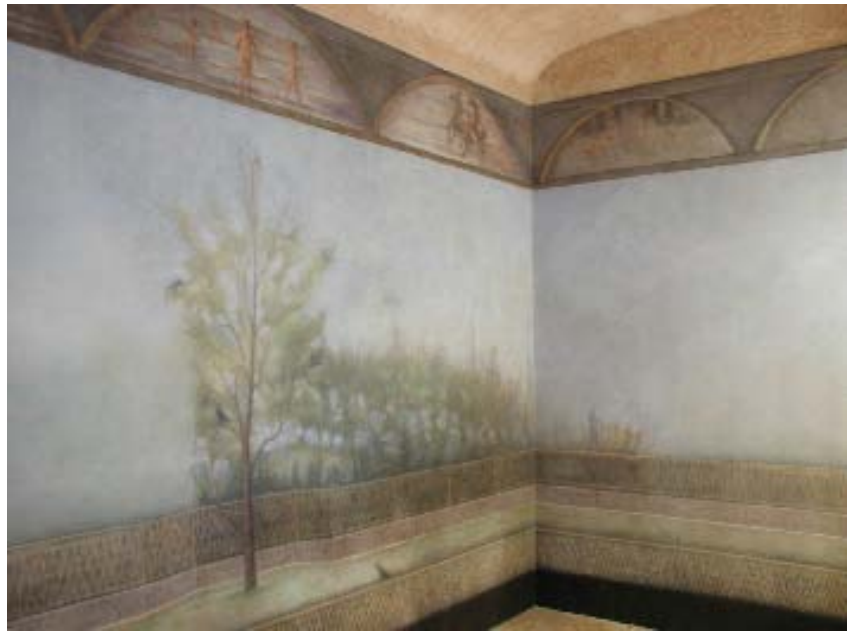
Central and right walls with partially completed lower part (fences) and "open areas" where the vegetation theme got lost as door openings were made under the hospital use.

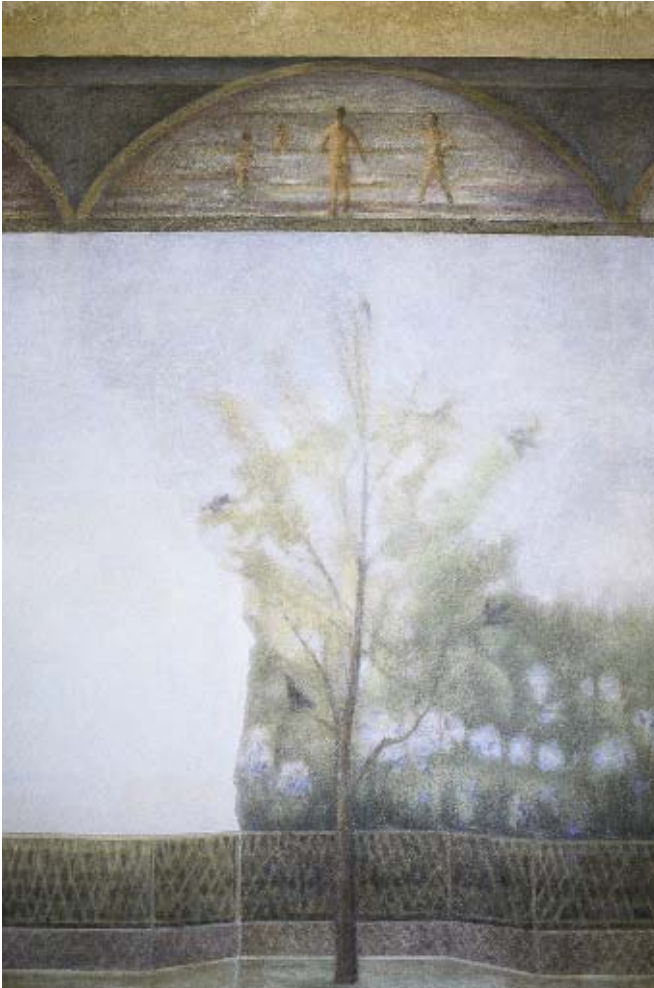
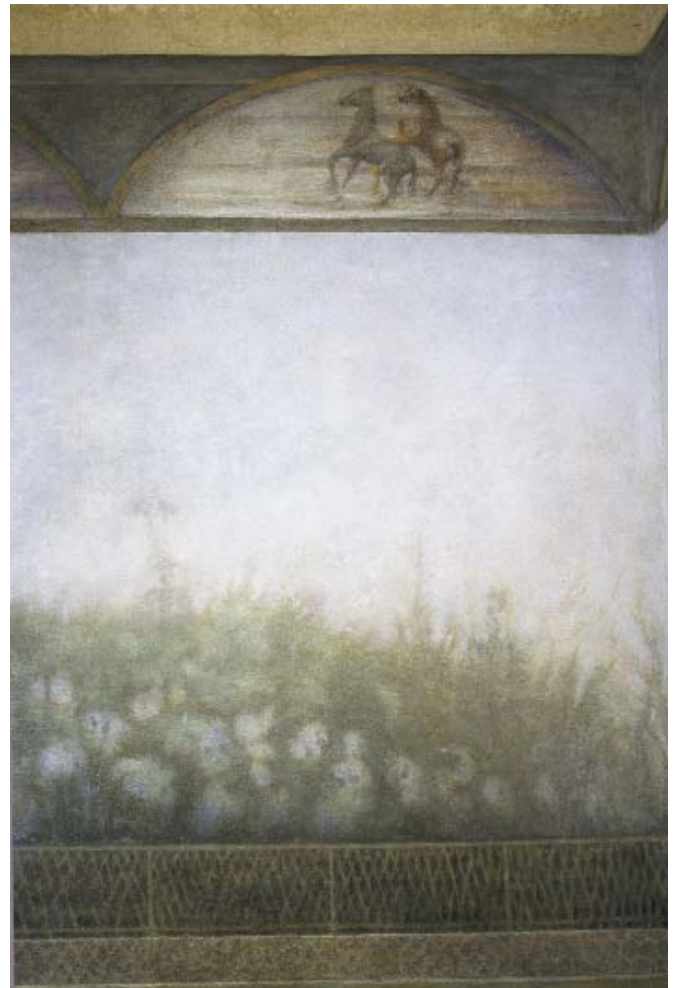
Details of the central wall including typical themes of Liebermann's own work around 1900: the bathing boys and the horses on the beach.
